Voron Design

possible misalignment of rails causing apparent twist.

To document what i think I am seeing with the dual rail. I misaligned the front x rail, and I think this caused a rotation twist around the x axis

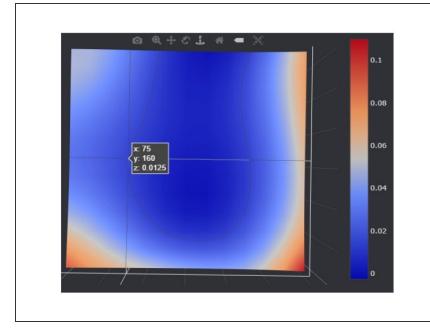
Step 1 — Issue: twist?

- I had an issue with my first layer height. my bed mesh showed 75,160 and 220,160 should be close to the same z but they were off by 0.08mm.
- Discord gurus diagnosed this as evidence of twist. And they are correct, but it is not the extrusion which is twisted.
- I found that the rails were slightly misaligned relative to the extrusion, this lets the carriage spiral around a straight extrusion (within the flex of the carriage and tolerance of the rails)

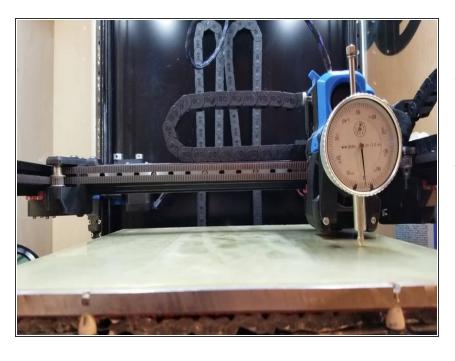
Step 2 — Measure twice..

- I mounted a dial indicator to the front of Afterburner and started taking measurements
- I found that the measured delta would vary with different z height. If this were simple tilt, the measurements would be the same no matter the z height.

The delta would vary from 19/1000 to 25/1000, the higher I went the larger it was. this allowed me to calculate the amount of "twist" and the rail misalignment

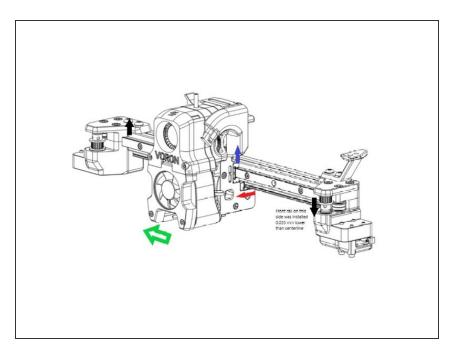
Step 3 — Identify the issue

- This diagram shows what I think is going on. In the AB, you align and install the front rail, then align the bottom rail to it.
- If the front rail is slightly misaligned higher on the left/lower on the right (black arrows), it will pull up on the carriage (gray arrow) when moved to the left (green arrow). The bottom rail is constrained in that direction, so it moves forward(red arrow), and the carriage is tilted.
- From the measurements I took, I was approx. 0.035mm high to the left and 0.035 mm low on the right. I calculated the twist at approx 0.4 degrees.
- But why haven't we seen this before? can't QGL take care of it?

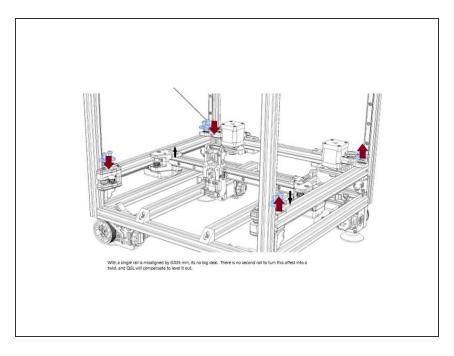
Step 4 — Why 2.2 has no issue here and why QGL can't fix it for Afterburner

- With 2.2 there is no bottom rail to turn tilt into twist. QGL can compensate for any misalignment by adjusting the y rails up and down
- With afterburner though, the bottom rail can turn this tilt into twist.
- QGL cannot fully adjust for twist, because it's only function is to adjust the 4 z stepper offsets so that 4 measurements are equal.
- QGL cannot compensate for twist and remain untilted. because of the size of the relative errors, it is biased to tilt correction

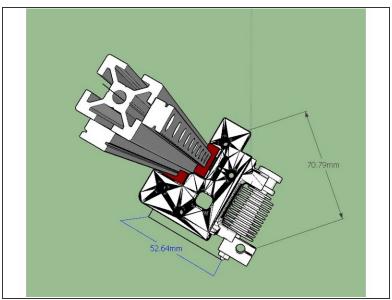
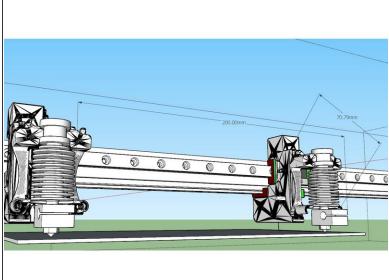
Step 5 — Effect at nozzle

- If the front rail is misaligned by 0.035 mm, then the twist over the x axis would be 2* atan(0.035/10)= 0.4 degrees. over the entire rail
- The nozzle is 70.79 mm away from centerline. So what is the effect relative to the build surface?
- Over 200 mm, the carriage would rotate only 0.2 degrees. but at a distance of 70.79mm from center, that works out to a lift of 0.18mm. (mine was less than this, 0.08 over 150mm)
- So yes, that could be the problem. but how to fix?

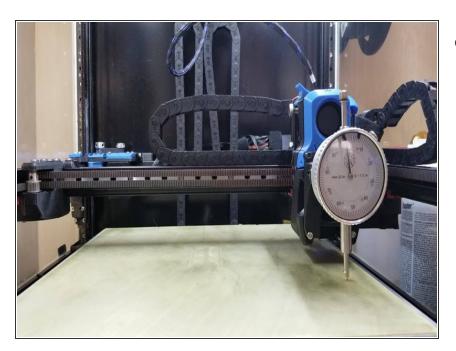
Step 8 — Results

This took several iterations.

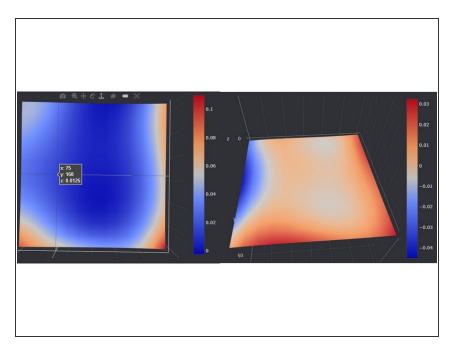
Step 9 — Effect of twist on mesh

- Mesh on the left is with the twist (0.4 degree) mesh on right is after fix.
- with my twist, as the probe moved left the twist would turn it away from the bed, exaggerating the distance
